Case Study:

IIS Automated Thermal Inspection System

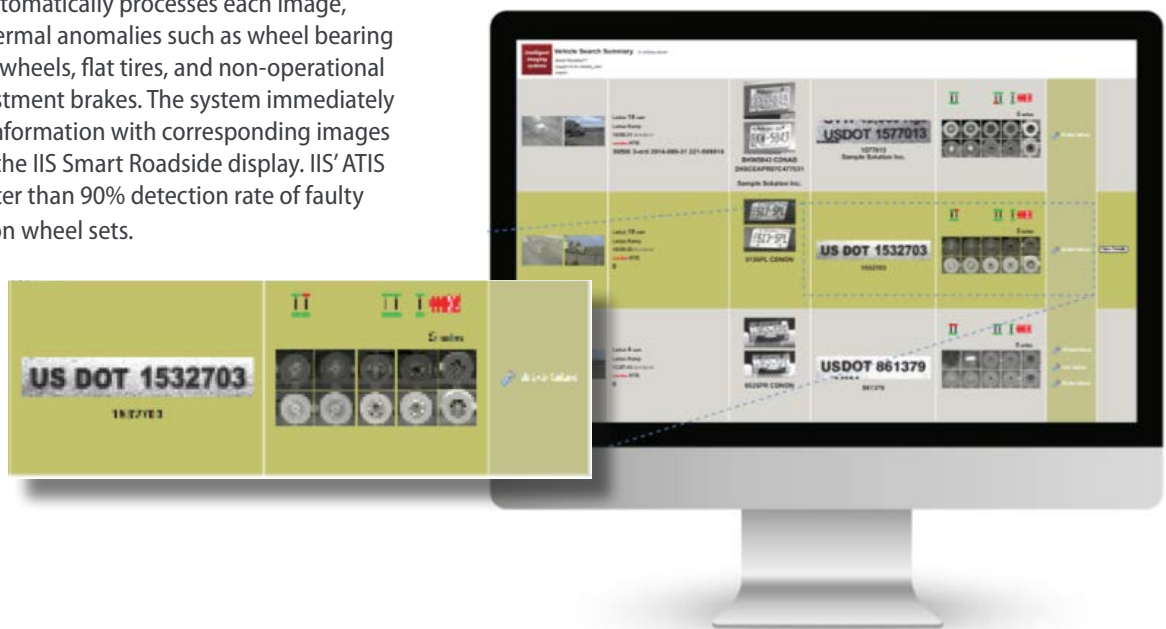
ATIS provides New Mexico's Commercial Motor Vehicle (CMV) officers with an additional layer of accurate real-time information on all passing CMVs. ATIS automatically reads and compares the thermal images of the tires, brakes and wheels on each side of the vehicle while it passes sensors installed on the ramp. High resolution thermal images are captured for each wheel set (both left & right) of each axle on the vehicle.

The system automatically processes each image, identifying thermal anomalies such as wheel bearing failures, loose wheels, flat tires, and non-operational or out of adjustment brakes. The system immediately displays this information with corresponding images and alerts on the IIS Smart Roadside display. IIS' ATIS features a better than 90% detection rate of faulty components on wheel sets.

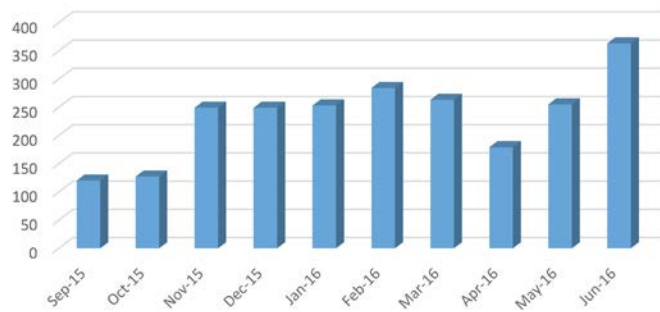
Figure 1 - OOS Incidents Anthony

Trucks Placed Out-of-Service

350% Increase in Out-Of-Service Incidents September 2015 to June 2016

Captain Tim Labier of the New Mexico State Police Commercial Vehicle Enforcement Bureau has found several benefits of using ATIS in their inspection process. The most significant impact has been a **more than 300% increase in Out-Of-Service violations** issued at the site after the integration of ATIS. Captain Labier stated "ATIS has increased our efficiency by assisting officers to focus their efforts on carriers requiring further investigation. By using this thermal inspection technology, we have replaced random inspections with qualified inspections, and we're taking more dangerous commercial vehicles off of the road."
